IMC Potash - Colonsay Structural Roof Repair - Emaco S88CA

STRUCTURE: Underground Air Ventilation Tunnel
LOCATION: Colonsay, SK
PROJECT DATE: 1996
JOB DURATION: 6 weeks
CLIENT CONTACT: Sam Koneru
AREA: 1,500 ft²
CONTRACTOR: Vector Construction Ltd.
Saskatchewan Branch

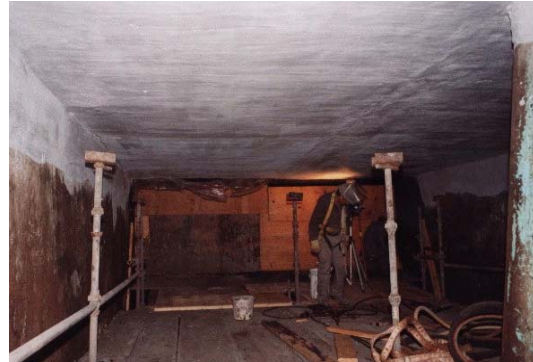
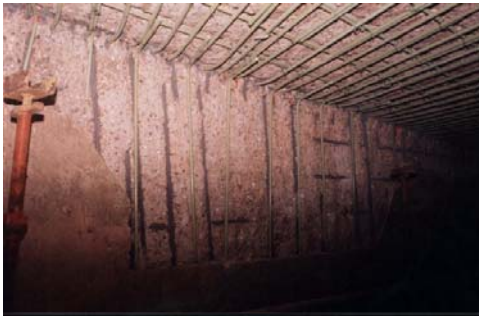
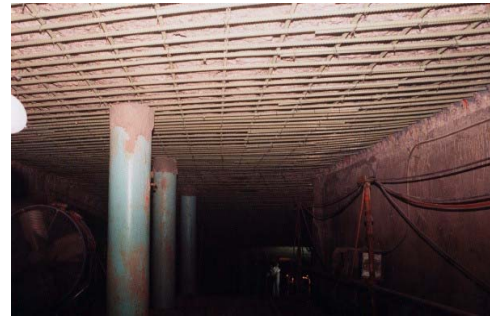
Problem: Delamination of the concrete in the ventilation tunnel roof caused by moisture and salt laden air being pumped through the area.

1. Remove delaminated, deteriorated concrete.
2. Remove existing reinforcing steel.
3. Install epoxy coated reinforcing steel as per original dimension.
4. Spray apply Emaco S88CA as required to rebuild the area with a minimum of 2" cover on the reinforcing steel. Trowel finish as required.
5. Coat repair area with 2 coats epoxy, Concessive 1305, highly chemical resistant coating.
