SaskPower Penstock Expansion Joint Grouting

STRUCTURE: E. B. Campbell Power Generating Station
LOCATION: Carrot River, SK
PROJECT DATE: January 1998
JOB DURATION: 7 days
CLIENT CONTACT: Tony Werrett
AREA: 4 Joints @ 1" x 20' diameter
CONTRACTOR: Vector Construction Ltd.
Saskatchewan Branch

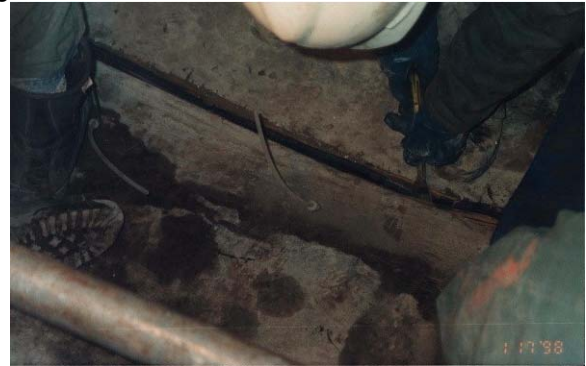
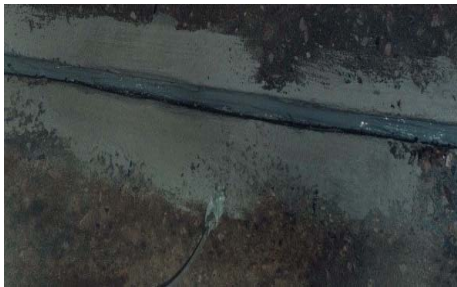
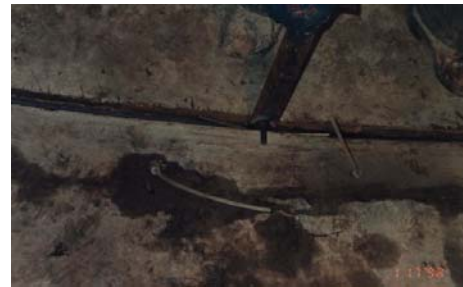
Problem; Water leaking out through the penstock wall into the earth fill dam, causing erosion of the earth fill. Failure of the waterstop installed during original construction in the expansion joints of the penstock.

Repair Product: MME Polycast Exp – 2 component urethane

- Clean out existing joint to a depth of the existing waterstop.
- Install foam soaked oakum against the existing waterstop to seal the backside of the expansion joint opening.
- Install an ethafoam rod as an outer seal and install 6" pipe nipples @ 4' on center to act as injection ports.
- Fill the chipped out area 1" X 3" X full perimeter with Emaco S88CA repair mortar.
- Mix and inject MME EXP Urethane resin starting at the six o'clock position and working up both sides filling to the twelve o'clock position.
