AGRIUM INC. Galvanic Jackets

STRUCTURE: Mill
LOCATION: Thickener Sump Area
PROJECT DATE: March 2001
JOB DURATION: 5 Days
CLIENT CONTACT: Mick Hobman
AREA: 4 Columns
CONTRACTOR: Vector Construction Ltd.
Saskatchewan Branch

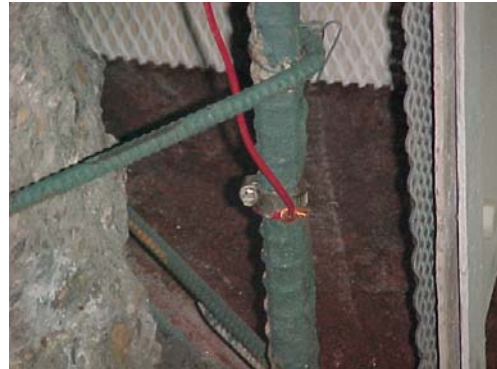
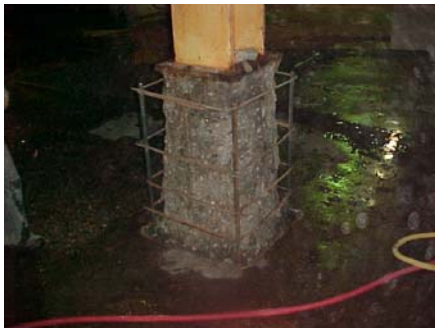
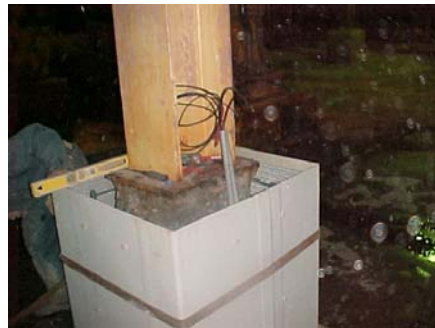
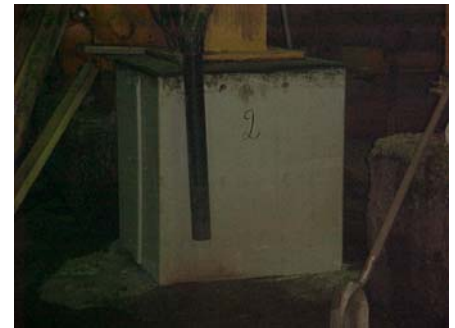
Problem: Deterioration of the existing structural steel concrete bases caused by corrosion of the reinforcing steel. These bases had been repaired by overbuilding them with concrete but corrosion of the steel in the original concrete caused premature failure of the original repair.

- Procedure:**
- i) Remove existing deteriorated concrete.
 - ii) Clean reinforcing steel and replace as required.
 - iii) Supply / install galvanic jackets pre-built to provide similar dimension to the original base design.
 - iv) Pour the galvanic jackets full of activated repair mortar.
 - v) Energize the system by connecting the zinc mesh to the reinforcing steel.
