Grain Silo Repairs

STRUCTURE: Grain Storage Silo's
LOCATION: Sioux City, IA
PROJECT DATE: Summer 2002
JOB DURATION: 6 weeks
CLIENT: AGP
CONTRACTOR: Vector Construction Group

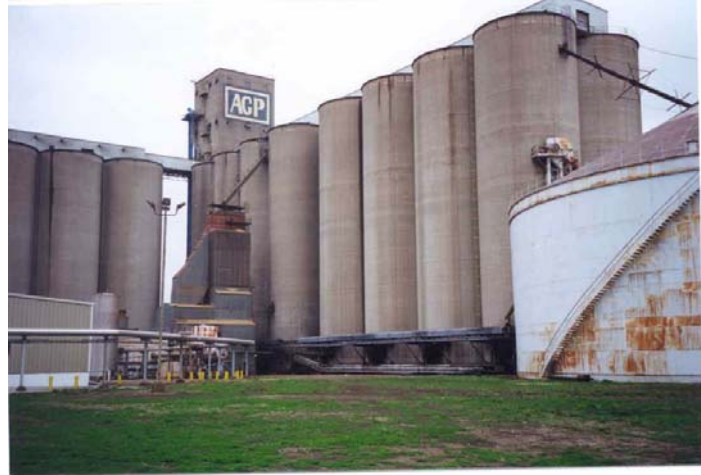
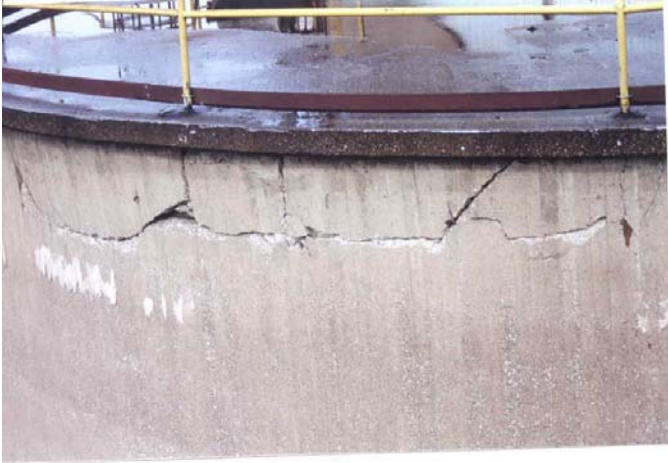
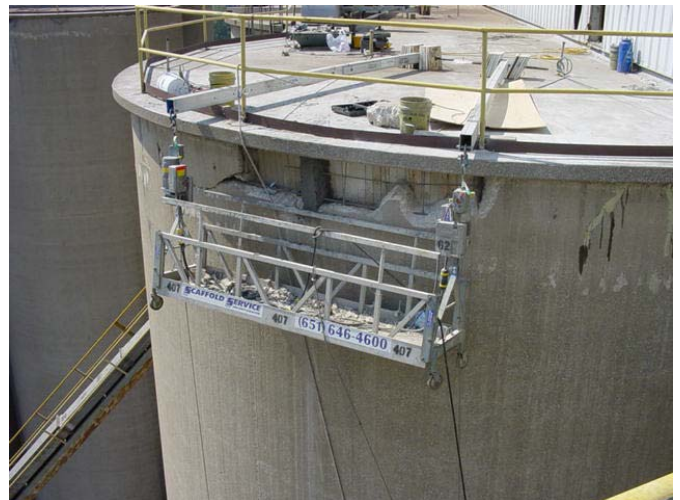
Years of continuous loading and unloading of the 22 Silo's along with significant freeze thaw damage have caused significant cracking and spalling of the concrete within the top 3 feet of the 140' high storage silos. Vector Construction was contacted to assist in determining the cause of the spalling and then develop a repair procedure that would provide a durable long lasting repair.

1. Install OSHA approved swing stages to safely access the work area.
2. Remove all deteriorated concrete and sandblast existing rebar.
3. Form and pour back all spalled areas with a pre-engineered pre-bagged repair mortar.
4. All cracks were repaired by means of epoxy injection.
