Meat Plant Processing Basement Joist Repair and Strengthening

STRUCTURE: Processing Basement Joist Repairs
LOCATION: Norfolk, NE
PROJECT DATE: Summer 2001
JOB DURATION: 8 weeks
CLIENT: IBP
CONTRACTOR: Vector Construction Group

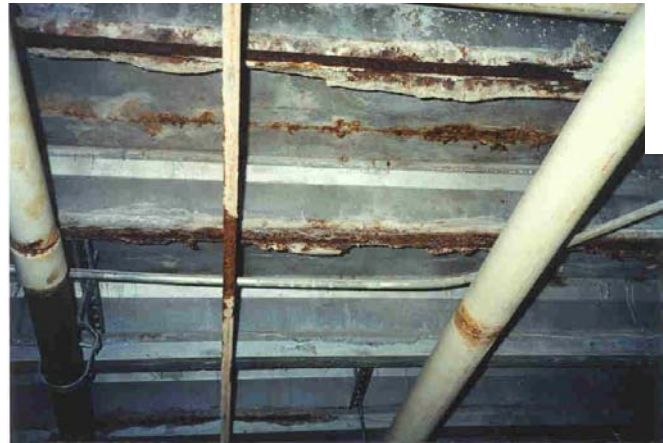
Years of high humidity and warm temperatures created a perfect environment for corrosion of the reinforcing steel in the poured in place joists in the processing floor. Vector Construction was contacted to develop a repair procedure that would restore the original designed load capabilities to the floor. All work would have to be performed with no impact on the plant operations while at the same time having no reduction in head room or no additional shoring post be left in the room.

1. Survey of entire room was conducted and it was determined that 77 joists would require repair.
2. In conjunction with a licensed structural engineer, stamped drawings were provided to the owner.
3. All failed concrete was removed and reinforcement bars cleaned.
4. Galvshield XP anodes were installed at the end of each repair to protect from future corrosion damage.
5. Repair areas were formed and poured back with an engineered repair material.
6. M-Brace Composite Strengthen System was installed to restore loading capacity of the floor.
