MIDTOWN PLAZA PARKING GARAGE GEMCRETE HDO CONCRETE OVERLAY

STRUCTURE: Underground Parking Garage

LOCATION: Midtown Plaza, Saskatoon, SK

CONTRACTOR: Vector Construction Ltd.
Saskatchewan Branch

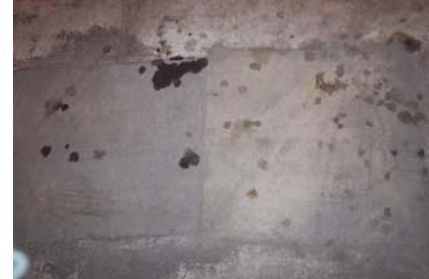
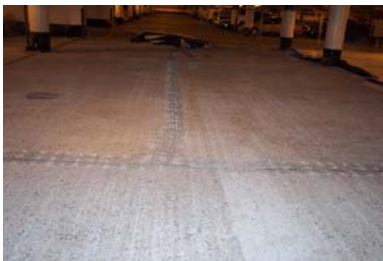
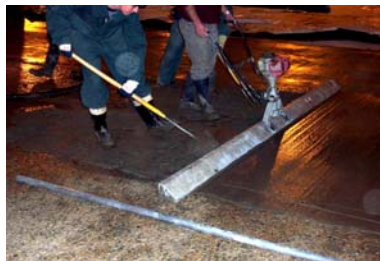
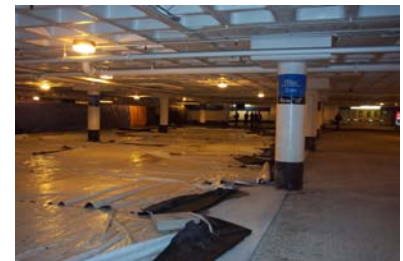
Problem: Surface deterioration of the existing concrete surface creating safety concerns for pedestrian traffic and making the area very difficult to clean properly.

- i) Proper surface preparation by scarifying the existing concrete substrate by milling 1/2" off leaving a surface with 1/4" amplitude.
- ii) High pressure water wash the scarified concrete substrate using a minimum 5,000 psi power wash.
- iii) Install welded wire mesh on all control joints and any cracks in the substrate.
- iv) Install Gemcrete Slurry as per manufacturer's recommended procedure.
- v) Install Gemcrete HDO at an average thickness of 1/2" as per manufacturer's recommended procedure.
- vi) Cure as per manufacturer's recommended procedures.
- vii) An extended life warranty is available from the product manufacturer.
