Saskatchewan Highways Bridge Parapet Wall Repair

STRUCTURE: Bridge Overpass
LOCATION: #7 Hwy over CN Rail
West of Saskatoon
PROJECT DATE: June 1996
JOB DURATION: 4 weeks
CLIENT CONTACT: Dave Altwasser
CONTRACTOR: Vector Construction Ltd.
Saskatchewan Branch

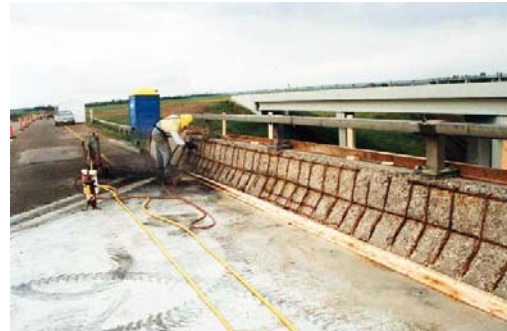
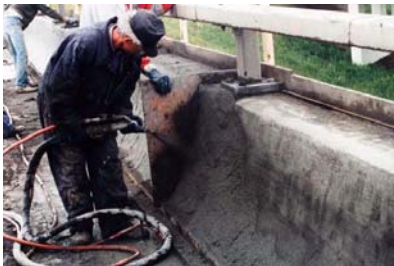
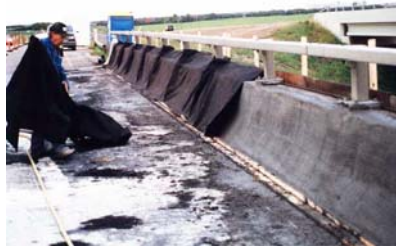
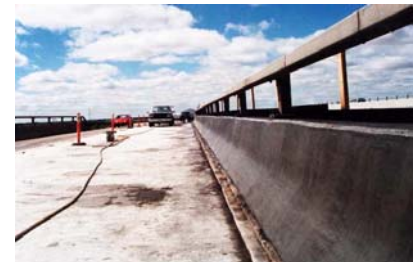
Problem: Salt induced corrosion of the reinforcing steel causing surface delamination of the concrete surface.

Area: Full length of both parapet walls on the east bound lanes of this bridge structure.

- Procedure:**
- i) Remove contaminated concrete to a depth of 1/2" behind reinforcing steel.
 - ii) Grit blast the entire surface, both reinforcing steel and concrete.
 - iii) Pre-soak the concrete substrate for 24 hours prior to installation of the repair mortar.
 - iv) Spray apply multiple lifts of Emaco S88CA repair mortar.
 - v) Finish surface to original dimension.
 - vi) Wet-cure the repair mortar for a minimum of 72 hours.
