Saskatchewan Highways Norcure Chloride Ion Removal System

STRUCTURE: Overpass
 LOCATION: #16 Hwy over #11 Hwy
 PROJECT DATE: 1994
 JOB DURATION: 3 months
 CLIENT CONTACT: Herve Bachelieu
 CONTRACTOR: Vector Construction Ltd.
 Saskatchewan Branch

#25-94SK-SK Hwys

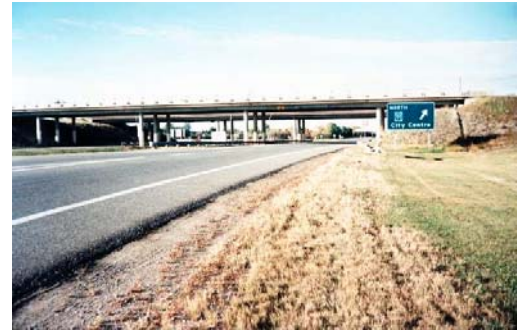
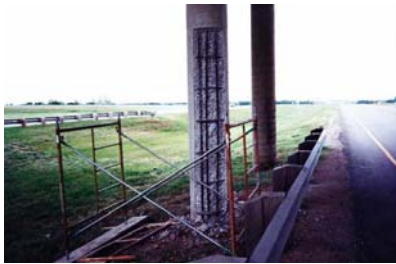
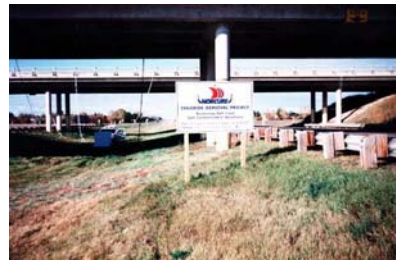
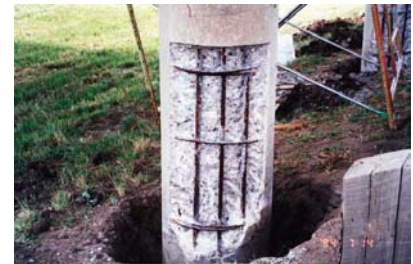
Problem: Chloride ion intrusion of the supporting columns causing deterioration of the structural integrity of the columns. Remove the chloride ion to stop future deterioration of the structure.

Area: Supporting columns from ground elevations to a height of 3 meters.

- Procedure:**
- i) Patch and repair any delaminated areas using standard concrete patch and repair practices.
 - ii) Install Titanium mesh over the area to be repaired.
 - iii) Install wetting agent medium.
 - iv) Connect electrical supply and energize the system as required.
 - v) Monitor readings for up to 3 months to determine extent of Chloride Ion removal.
