IMC Potash, Esterhazy Column Repairs

STRUCTURE: Thickener Area Structural Column Bases

LOCATION: K-2 Minesite, Esterhazy

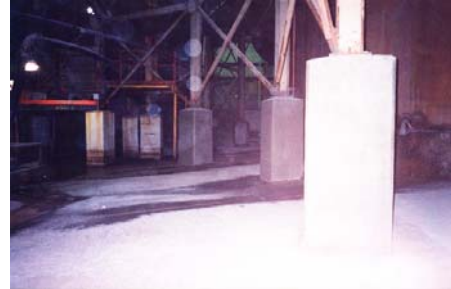
Problem: Flooding of the area with salt brine causing surface deterioration of the concrete and corrosion of the reinforcing steel.

Repair System: - repair to original dimension with Target Redi-Crete
- Gemite Cem-Kote Flex ST surface coating

- i) Proper surface preparation and repair reinforcing steel as required.
- ii) Form to original dimension and pour with Target Redi-Crete.
- iii) Spray apply Gemite Cem-Kote Flex ST as per manufacturer's recommended procedures.
