Saskatchewan Highways & Transportation Concrete Girder Repair Pre-tensioned Cable Reinforcing

STRUCTURE: Hwy #2 over Hwy #1 Bridge Overpass
LOCATION: Moose Jaw, SK
PROJECT DATE: October 2004
JOB DURATION: 10 Working Days
CLIENT: Sask. Highways & Transportation
CONTACT: Kelvin DeGrow
CONTRACTOR: Vector Construction Ltd.
Saskatoon Branch

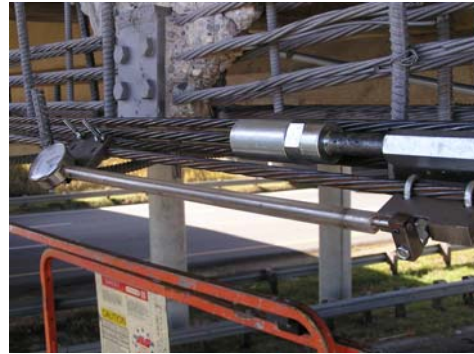
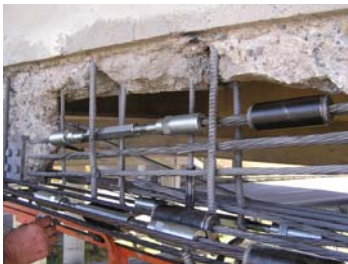
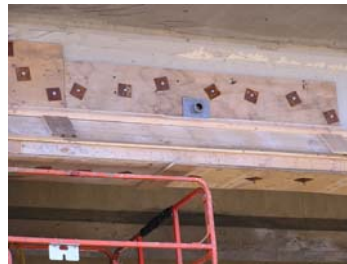
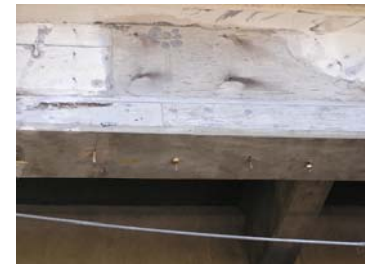
Problem: Bridge girder was damaged from being impacted by an over height load and breaking several of the pre-stressed structural cables in the girder.

Area: Approximately 15' length of damaged girder mid-span between the supporting piers.

- i) Remove all cracked and broken concrete.
- ii) Expose all pre-stressed cables to observe any physical damage to the cables.
- iii) Install Grabb-It couplers as required to join the cables properly.
- iv) Tension the couplers to the required tension using the proper tensioning guage – approximate tension requirement was 27 KIPS.
- v) Form and repair the beam to its original dimension using Thoroc LA40.
