Saskatchewan Highways & Transportation Spray Applied EMACO S88CR Gunite Procedure

STRUCTURE: Battle River Bridge
Parapet Walls

LOCATION: North Battleford, SK

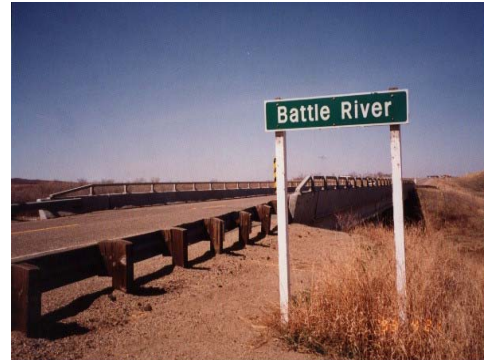
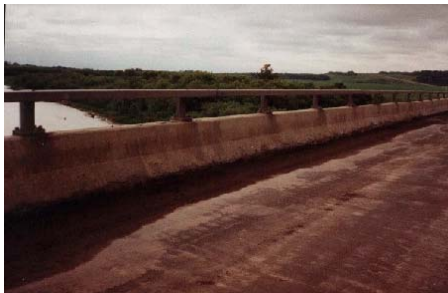
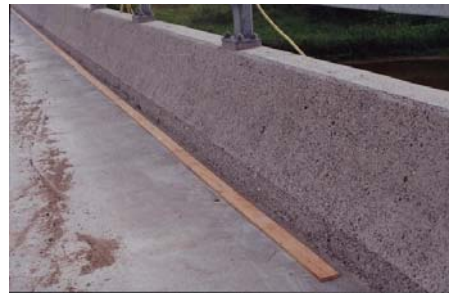
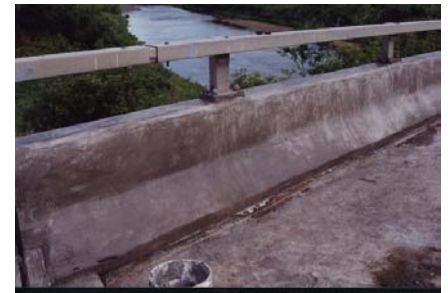
Problem: Deterioration of the concrete face of the bridge retaining parapet walls caused by de-icing salts used on the road. The parapet walls were made using light weight aggregate in original construction.

Area: Full interior side face & top-side of the parapet walls.

- Procedure:**
- Remove deteriorated concrete.
 - Grit blast entire surface.
 - High pressure water wash entire surface.
 - Pre-soak the repair area for 24 hours prior to installing material.
 - Spray apply EMACO S88 to rebuild the parapet overbuild ½" deeper than original dimension.
