Churchill Elevator Rehabilitation Structural Repair and Window Installation

STRUCTURE:	Concrete Grain Elevator Annex Silos, Workhouse and Trackshed
LOCATION:	Churchill, Manitoba
PROJECT DATE:	June to October 1999
JOB DURATION:	5 Months
CONTRACT AMOUNT:	\$ 660,000
CLIENT:	Hudson Bay Port Company
CONTRACTOR:	Vector Construction Group, Manitoba Branch

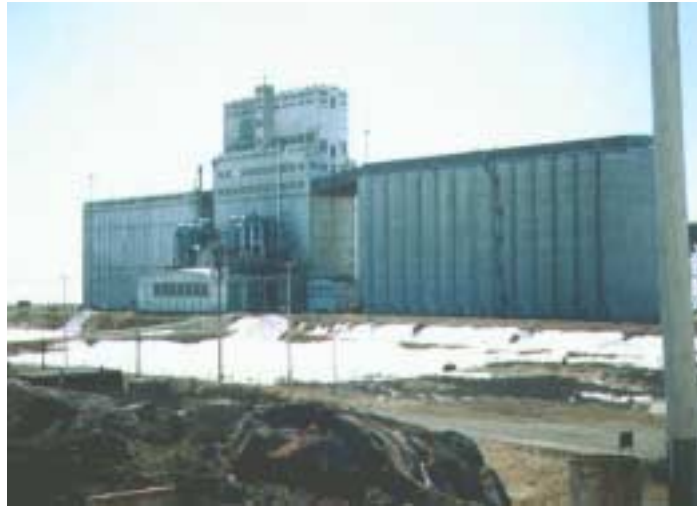
The slow deterioration of the building envelope over many years included freeze/thaw damage to the foundation, shifting and cracking of structural concrete beams, breakdown of contraction joints between sections of building, damage to the concrete around the windows, and corrosion damage to the window frames.

Vector Construction was hired to establish a priority list of the most critical repairs required, and to conduct these repairs as efficiently as possible. The short available working season, and coordination with the day to day grain moving activities, were important considerations in the planning of the project. A combination of concrete repair for the foundations, epoxy injection for the structural beam repairs, and urethane injection for the waterproofing of the contraction joints was used to complete the priority repairs to the main structure. The replacement of some of the window frames, including the adjacent deteriorated concrete, was completed in order of proximity to critical operating equipment in the workhouse.
